# WENRA

## Recommendations Following the Discovery of Intergranular Stress Corrosion Cracks on some French Pressurized Water Reactors

November 2023

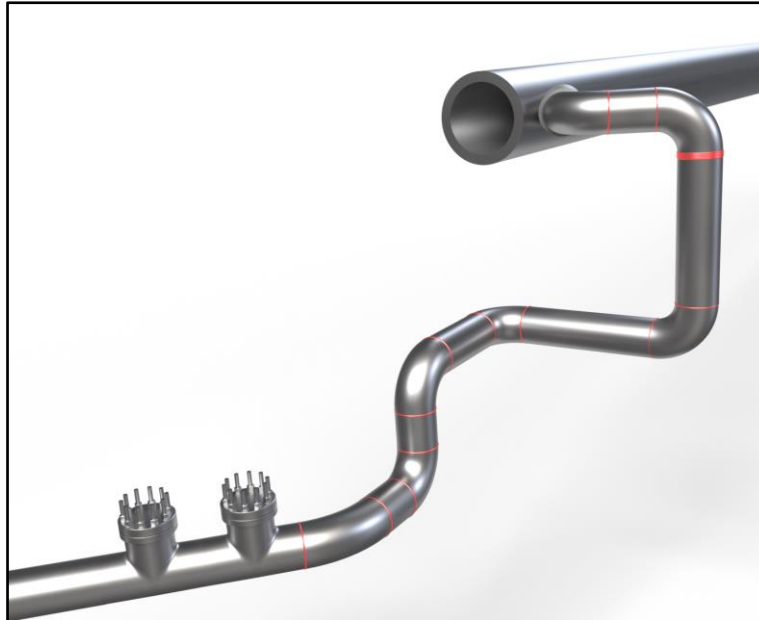
*Figure 1: illustration of typical geometry of a non-isolable part of an auxiliary pipe of the main-primary system on a French pressurized water reactor. The welds that are susceptible to be affected are outlined in red.*

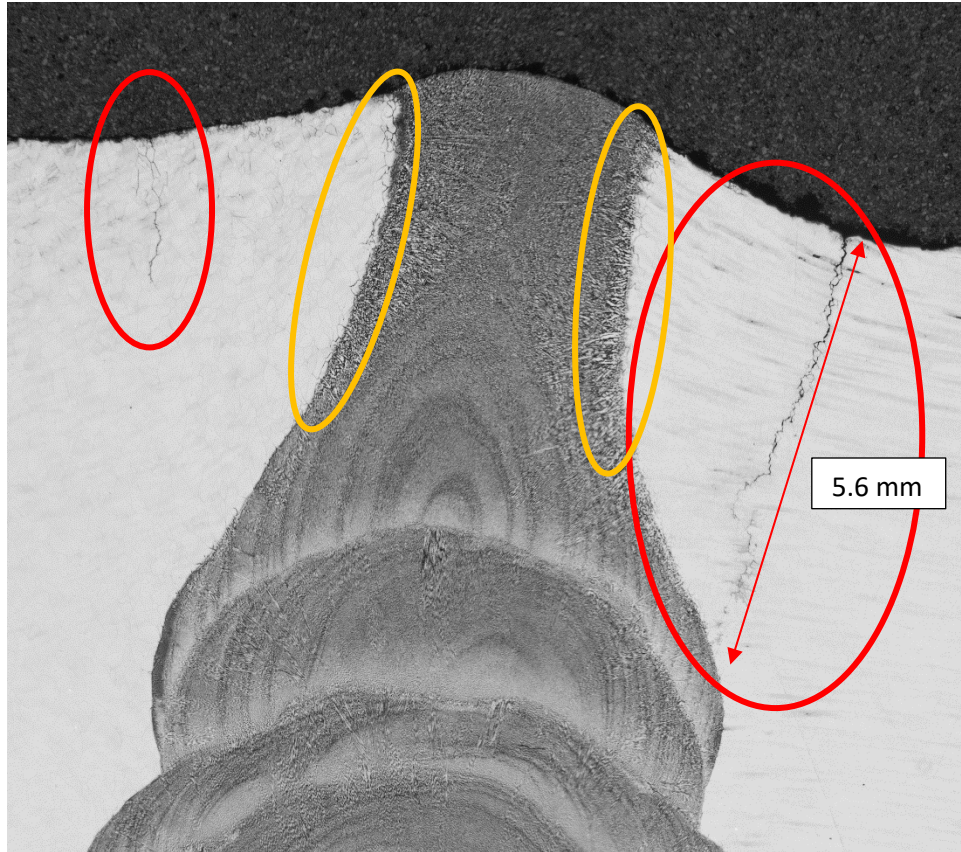
An intergranular stress corrosion crack (IGSCC)<sup>1</sup> was discovered in France on October 21<sup>st</sup>, 2021, during the ten-yearly inspection of reactor 1 of Civaux plant<sup>2</sup>. It was found on a weld of a 12" emergency core cooling system (ECCS) pipe, on the non-isolable part of this pipe.

The crack was extended along the whole length of the weld (360°) and its maximum depth was measured at 5.6 mm, after the removal of the weld for destructive analysis.

A similar IGSCC crack, of smaller depth, was later found on the same reactor on a weld of the non-isolable part of the residual heat removal system (RHRS).

*Figure 2: typical location of IGSCC cracks in the thermally affected area of a weld (cracks discovered on Civaux 1 reactor in 2021)*

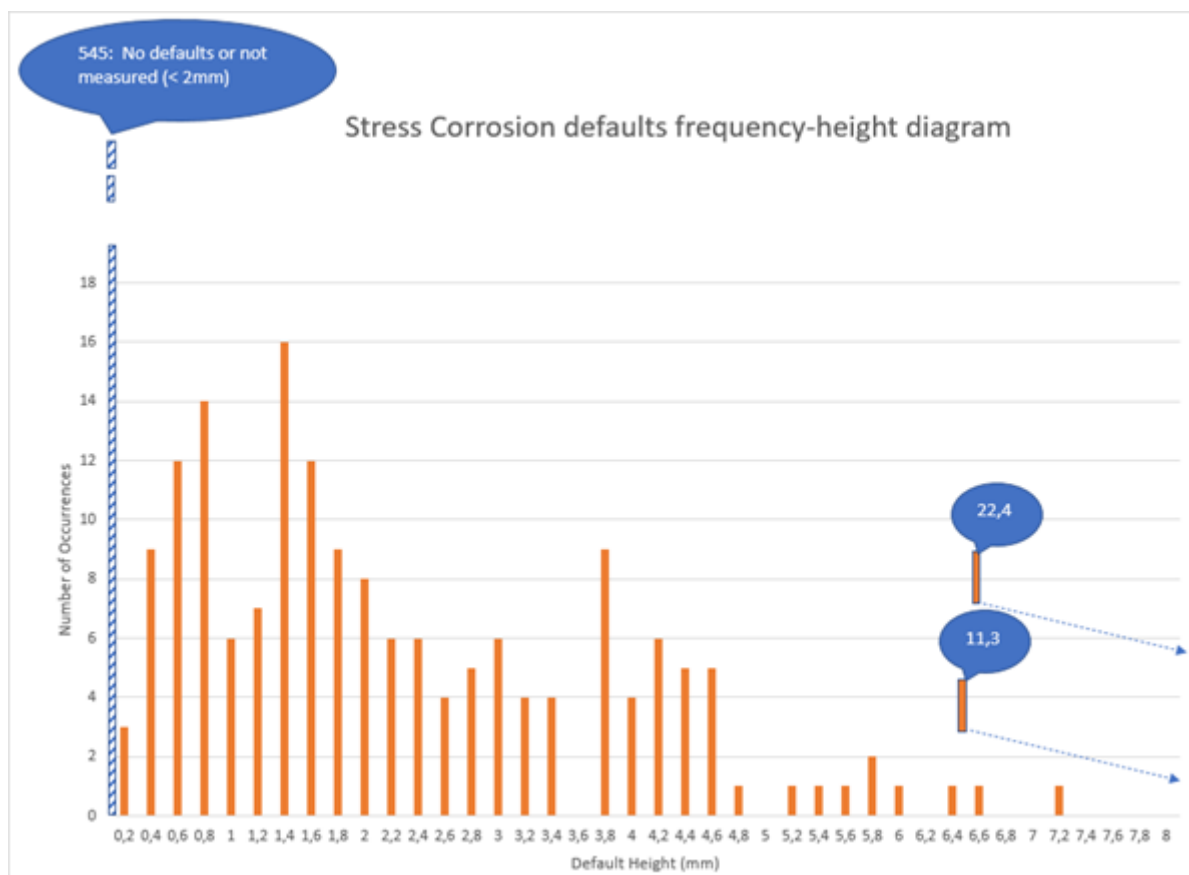
IGSCC cracks were found on several pipes of the ECCS and RHRS systems of the French PWRs, with different type of reactors, systems, and susceptibility. A distribution of the measured size of the cracks is given in figure 3 below, for the cracks examined in laboratory after UT testing.

Figure 3: Distribution of IGSCC cracks depth (in mm) on ECCS and RHRS welds examined between the end of 2021 and the beginning of 2023, from licensee EDF

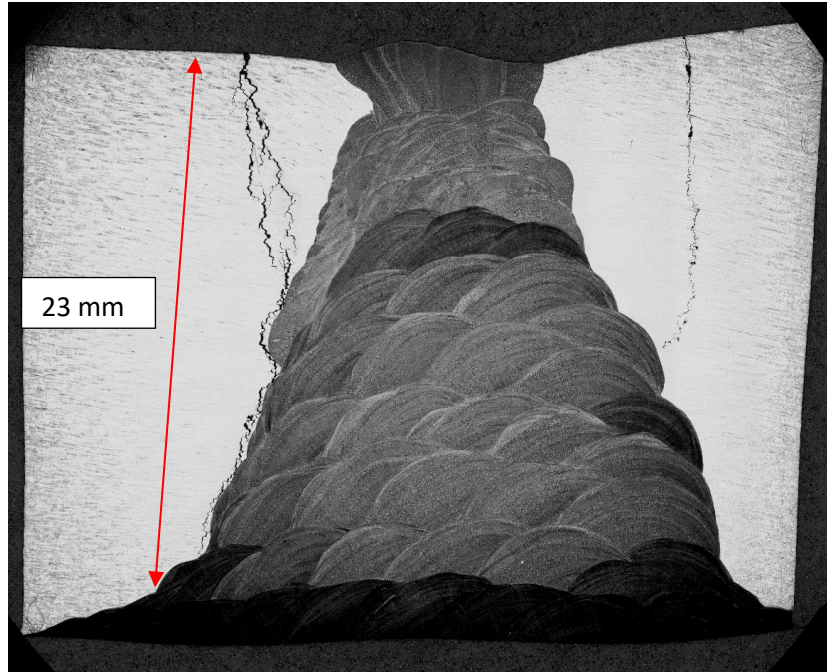
- An IGSCC crack was found on Penly 1 reactor, on a weld of a pipe of the ECCS system, limited in extension (around 150 mm which is roughly a quarter of the length of the weld) but with a very important depth (23 mm, the thickness of the pipe wall being around 25 mm). The maximum depth of this crack was not typical of the distribution observed before. The current understanding is that this weld having been repaired twice during the manufacturing stage of the reactor, at the exact same location where the crack was observed, was a contributing factor to the crack initiation and growing. Indeed, weld repairs modify the distribution and intensity of residual stress, and increase material hardening in the inner surface of the pipe.

*Figure 4: 23 mm deep IGSCC crack discovered on a weld of Penly reactor safety injection system, on a part of the weld that had been repaired during the manufacturing.*

The inspection programme described in 3.2 and 3.3 was therefore completed by the scheduling of the inspection of all the welds of ECCS and RHRS systems above 8" in diameter that had been repaired according to the manufacturing reports.

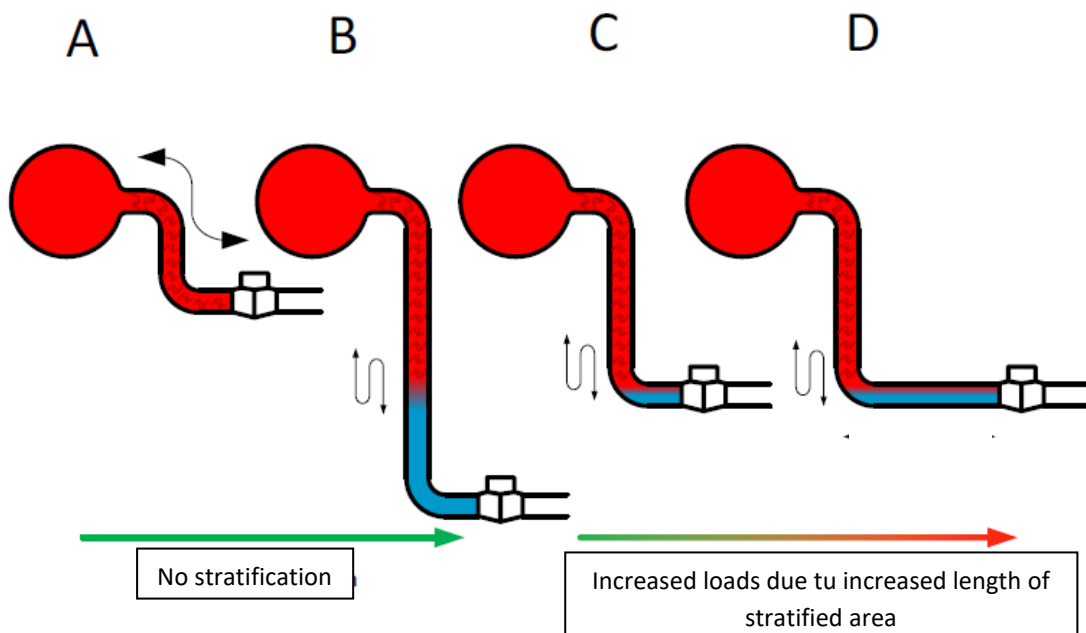
Studies on the pipes with the highest number of IGSCC cracks also showed that their geometry is very specific and allow the thermal stratification phenomenon to occur, as illustrated in figure 5 below. The additional stress in operation resulting from thermal stratification could explain the higher susceptibility of some particular pipe design to IGSCC or fatigue cracks.

*Figure 5: illustration from EDF showing the effect of an auxiliary pipe design on thermal stratification. The water circulation within the main primary pipes generates a vortex that penetrates into the*

*auxiliary pipe. The water in the auxiliary pipe is therefore at the same temperature as the main primary pipes in the length that is penetrated by the vortex. If the vortex ends up in a horizontal part of the pipe, there is a superposition of a cold and a hot water layers inducing a bending stress.*
