Western European
WENRA
Nuclear Regulators Association

Recommendations Following the Discovery of Intergranular Stress Corrosion Cracks on some French Pressurized Water Reactors

(Rev 1[1])

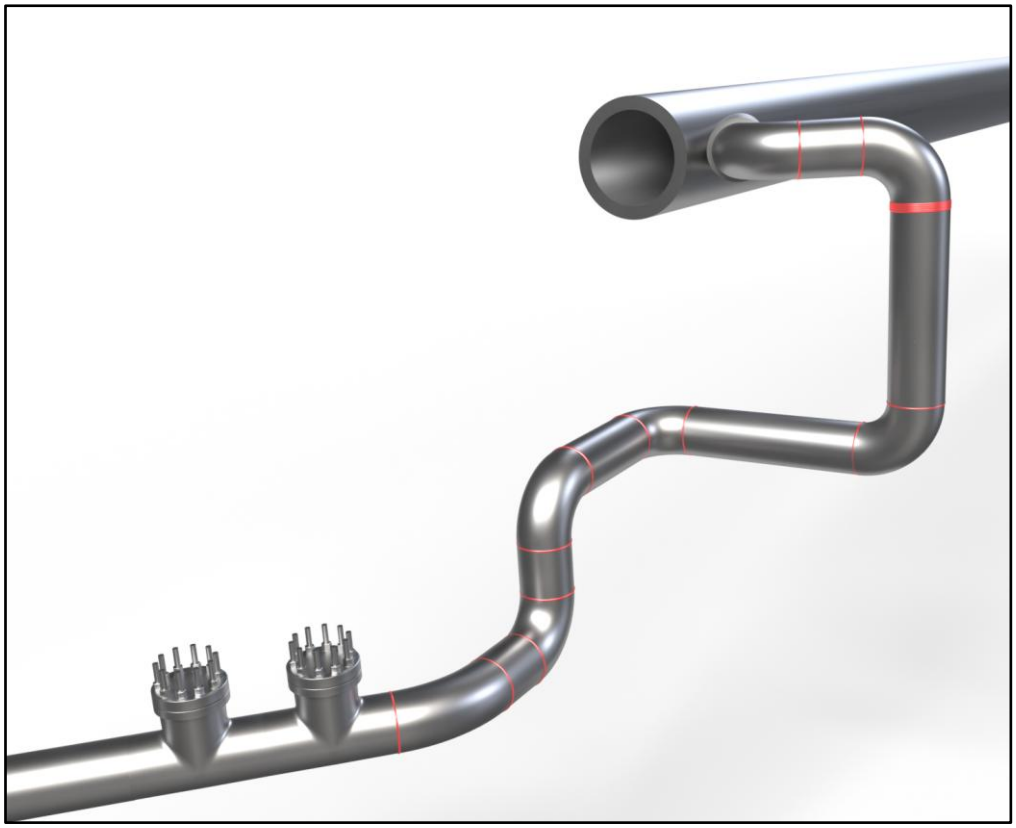
Figures 1 and 2 below show the typical location of the cracks that were found.

Figure 1: illustration of typical geometry of a non-isolable part of an auxiliary pipe of the main-primary system on a French pressurized water reactor. The welds that are susceptible to be affected are outlined in red. Findings in France show that, for this particular geometry, affected welds are those in the upper part of the pipe that are subject to the highest temperature.

Figure 2: typical location of IGSCC cracks in the thermally affected area of a weld (cracks discovered on Civaux 1 reactor in 2021)

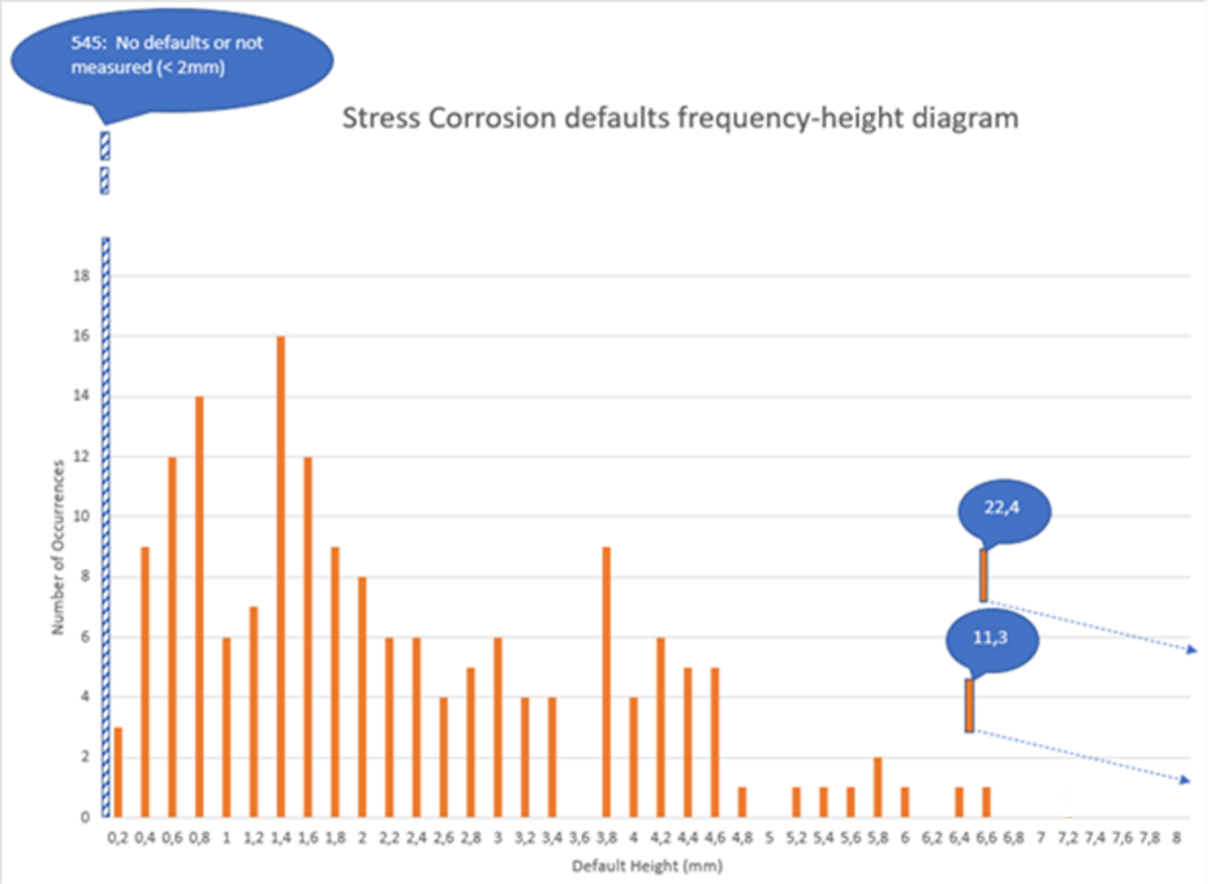
IGSCC cracks were found on several pipes of the ECCS and RHRS systems of the French PWRs, with different type of reactors, systems, and susceptibility. A distribution of the measured size of the cracks is given in figure 3 below, for the cracks examined in laboratory after UT testing.

Figure 3: Distribution of IGSCC cracks depth (in mm) on ECCS and RHRS welds examined between the end of 2021 and the beginning of 2023, from licensee EDF

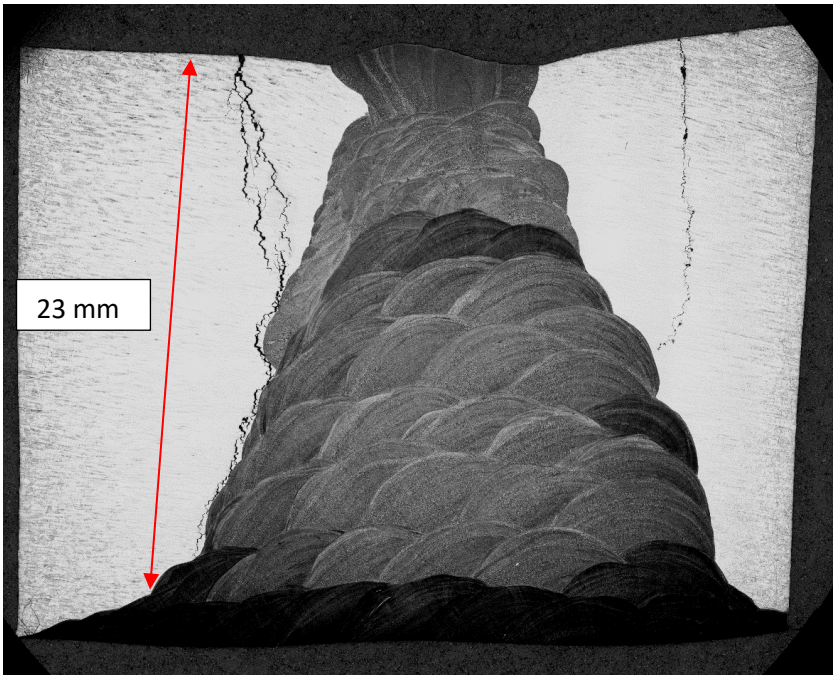
- An IGSCC crack was found on Penly 1 reactor, on a weld of a pipe of the ECCS system, limited in extension (around 150 mm which is roughly a quarter of the length of the weld) but with a very important depth (23 mm, the thickness of the pipe wall being around 25 mm). The maximum depth of this crack was not typical of the distribution observed before. The current understanding is that this weld having been repaired twice during the manufacturing stage of the reactor, at the exact same location where the crack was observed, was a contributing factor to the crack initiation and growing. Indeed, weld repairs modify the distribution and intensity of residual stress, and increase material hardening in the inner surface of the pipe.

Figure 4: 23 mm deep IGSCC crack discovered on a weld of Penly reactor safety injection system, on a part of the weld that had been repaired during the manufacturing.

The inspection programme described in 3.2 and 3.3 was therefore completed by the scheduling of the inspection of all the welds of ECCS and RHRS systems above 8" in diameter that had been repaired according to the manufacturing reports.

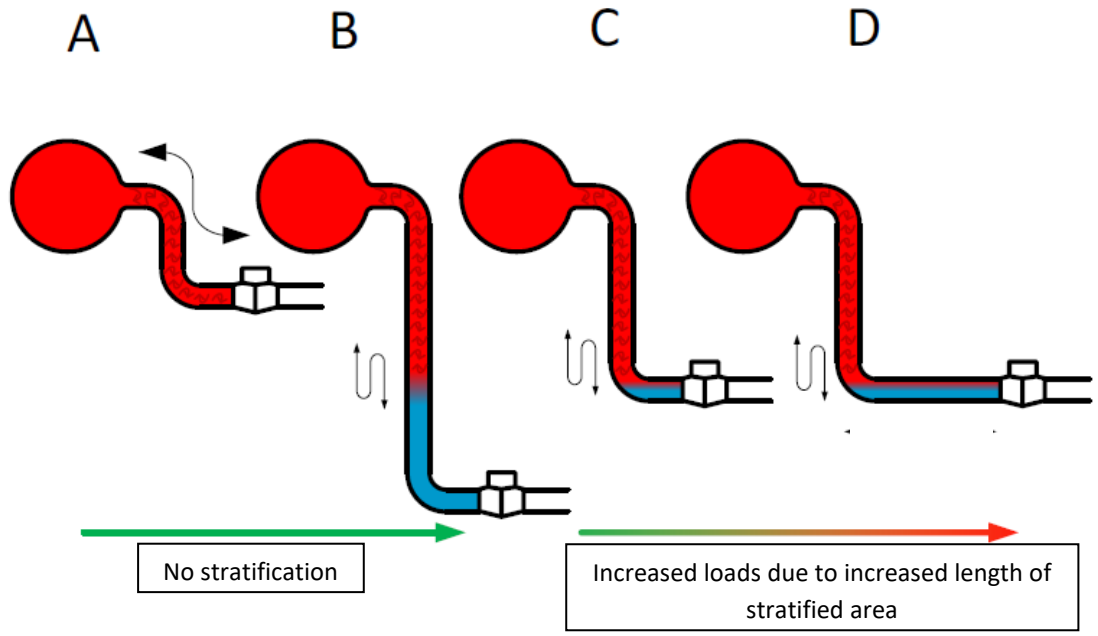
Studies on the pipes with the highest number of IGSCC cracks also showed that their geometry is very specific and allow the thermal stratification phenomenon to occur, as illustrated in figure 5 below. The additional stress in operation resulting from thermal stratification could explain the higher susceptibility of some particular pipe design to IGSCC or fatigue cracks.

Figure 5: illustration from EDF showing the effect of an auxiliary pipe design on thermal stratification. The water circulation within the main primary pipes generates a vortex that penetrates into the

auxiliary pipe. The water in the auxiliary pipe is therefore at the same temperature as the main primary pipes in the length that is penetrated by the vortex. If the vortex ends up in a horizontal part of the pipe, there is a superposition of a cold and a hot water layers inducing a bending stress.
