Western European
WENRA
Nuclear Regulators Association

Recommendations Following the Discovery of Intergranular Stress Corrosion Cracks on some French Pressurized Water Reactors

(Rev 1[1])

November 2026

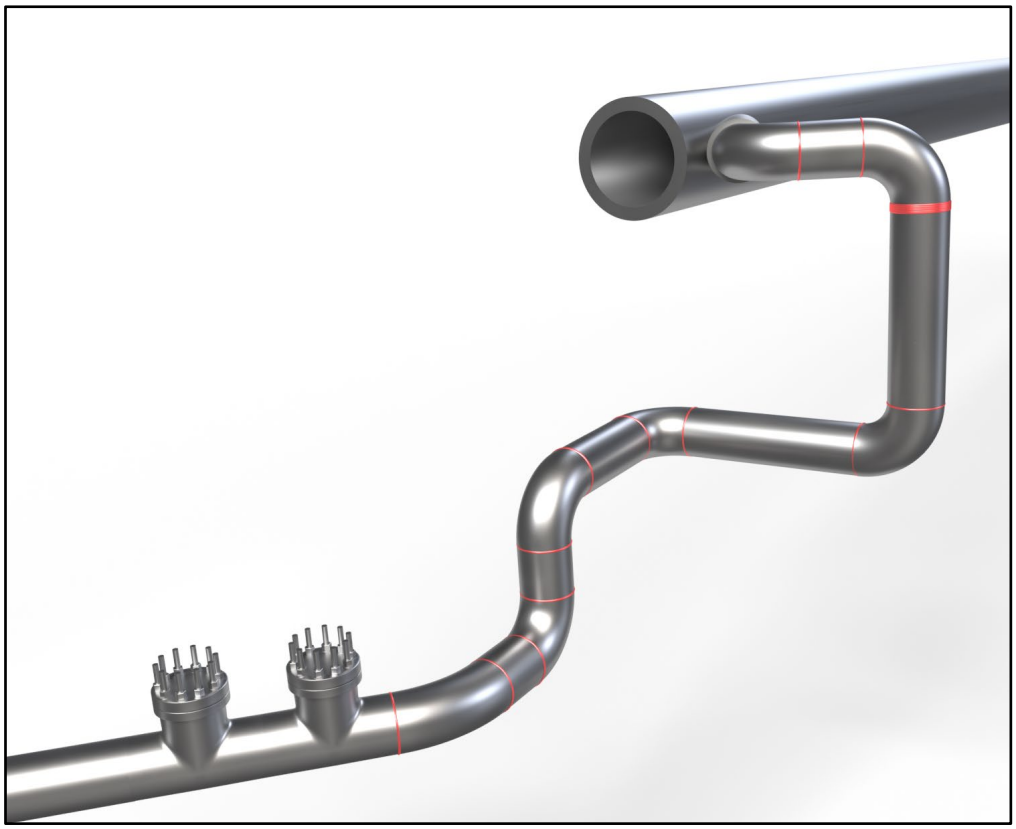
An intergranular stress corrosion crack (IGSCC)[2] was discovered in France on October 21st, 2021, during the ten-yearly inspection of reactor 1 of Civaux plant[3]. It was found on a weld of a 12" emergency core cooling system (ECCS) pipe, on the non-isolable part of this pipe.

The crack was extended along the whole length of the weld (360°) and its maximum depth was measured at 5.6 mm, after the removal of the weld for destructive analysis.

Figure 1: illustration of typical geometry of a non-isolable part of an auxiliary pipe of the main-primary system on a French pressurized water reactor. The welds that are susceptible to be affected are outlined in red. Findings in France show that, for this particular geometry, affected welds are those in the upper part of the pipe that are subject to the highest temperature.

Figure 2: typical location of IGSCC cracks in the thermally affected area of a weld (cracks discovered on Civaux 1 reactor in 2021)

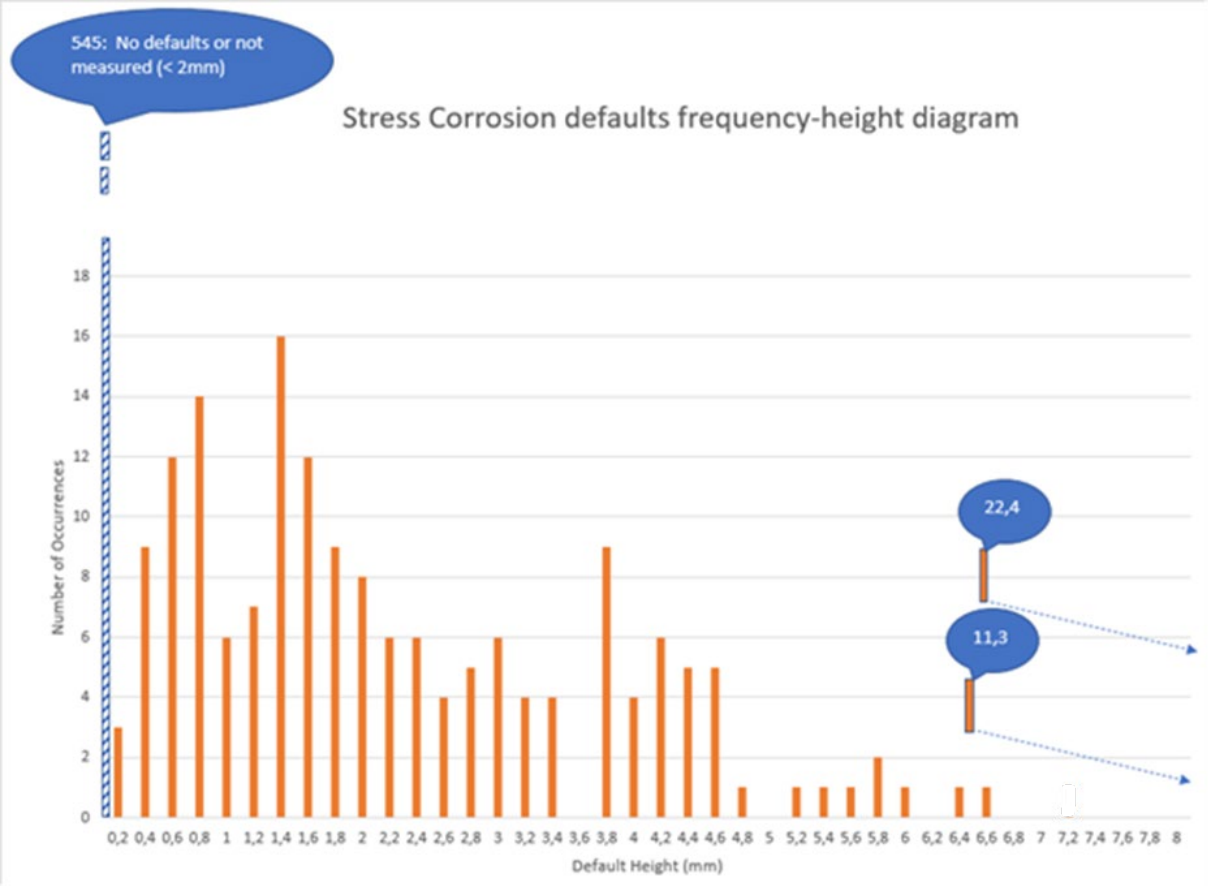
IGSCC cracks were found on several pipes of the ECCS and RHRS systems of the French PWRs, with different type of reactors, systems, and susceptibility. A distribution of the measured size of the cracks is given in figure 3 below, for the cracks examined in laboratory after UT testing.

Figure 3: Distribution of IGSCC cracks depth (in mm) on ECCS and RHRS welds examined between the end of 2021 and the beginning of 2023, from licensee EDF

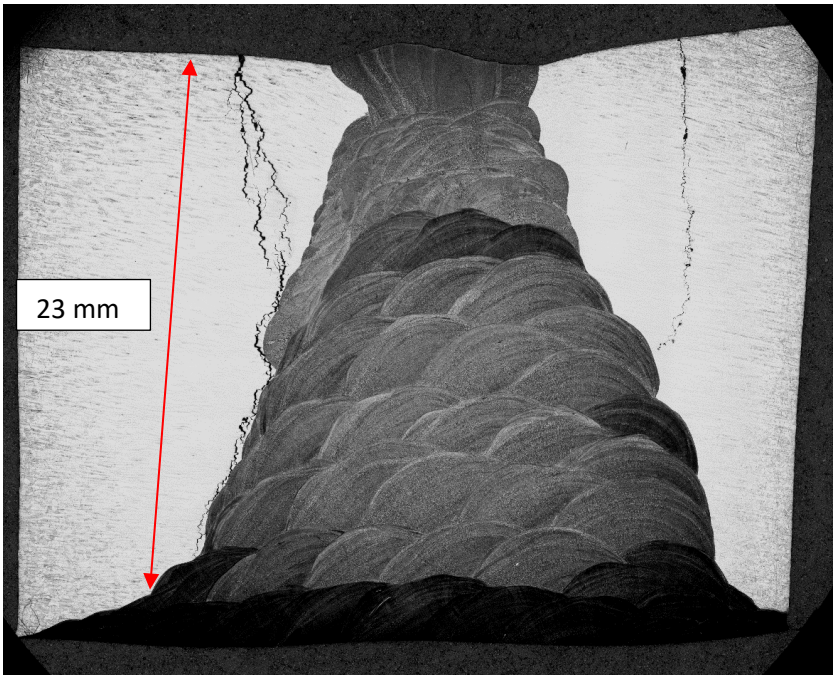
- An IGSCC crack was found on Penly 1 reactor, on a weld of a pipe of the ECCS system, limited in extension (around 150 mm which is roughly a quarter of the length of the weld) but with a very important depth (23 mm, the thickness of the pipe wall being around 25 mm). The maximum depth of this crack was not typical of the distribution observed before. The current understanding is that this weld having been repaired twice during the manufacturing stage of the reactor, at the exact same location where the crack was observed, was a contributing factor to the crack initiation and growing. Indeed, weld repairs modify the distribution and intensity of residual stress, and increase material hardening in the inner surface of the pipe.

Figure 4: 23 mm deep IGSCC crack discovered on a weld of Penly reactor safety injection system, on a part of the weld that had been repaired during the manufacturing.

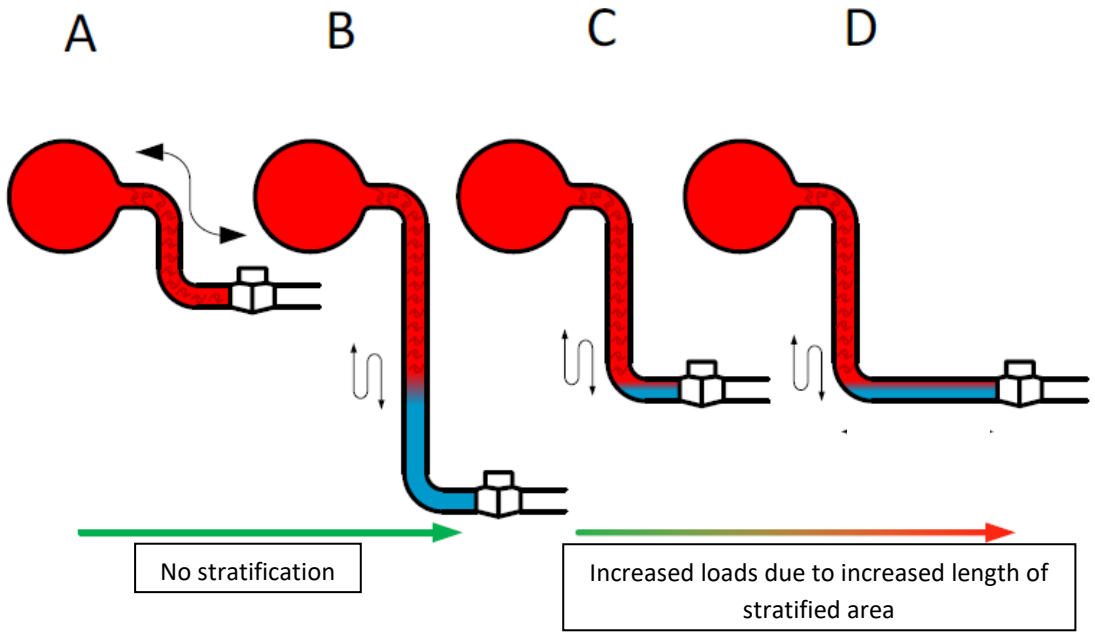
Studies on the pipes with the highest number of IGSCC cracks also showed that their geometry is very specific and allow the thermal stratification phenomenon to occur, as illustrated in figure 5 below. The additional stress in operation resulting from thermal stratification could explain the higher susceptibility of some particular pipe design to IGSCC or fatigue cracks.

Figure 5: illustration from EDF showing the effect of an auxiliary pipe design on thermal stratification. The water circulation within the main primary pipes generates a vortex that penetrates into the

auxiliary pipe. The water in the auxiliary pipe is therefore at the same temperature as the main primary pipes in the length that is penetrated by the vortex. If the vortex ends up in a horizontal part of the pipe, there is a superposition of a cold and a hot water layers inducing a bending stress.
